NASA CR-170597

TECHNICAL AND INVESTIGATIVE SUPPORT FOR HIGH
DENSITY DIGITAL SATELLITE RECORDING SYSTEMS

Progress Reports #16-18

Covering Reporting Period November, 1982 - January, 1983

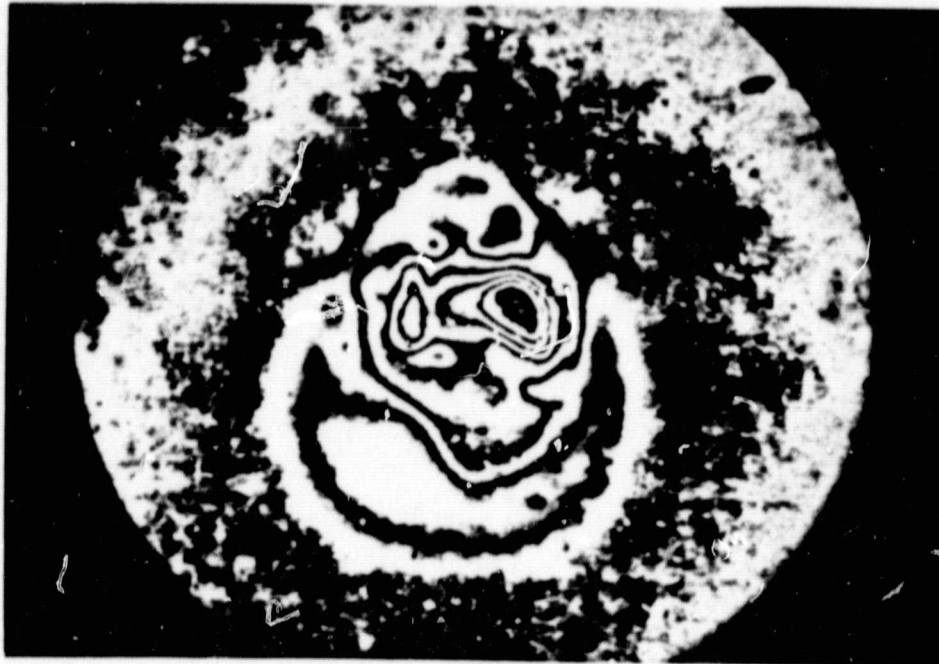
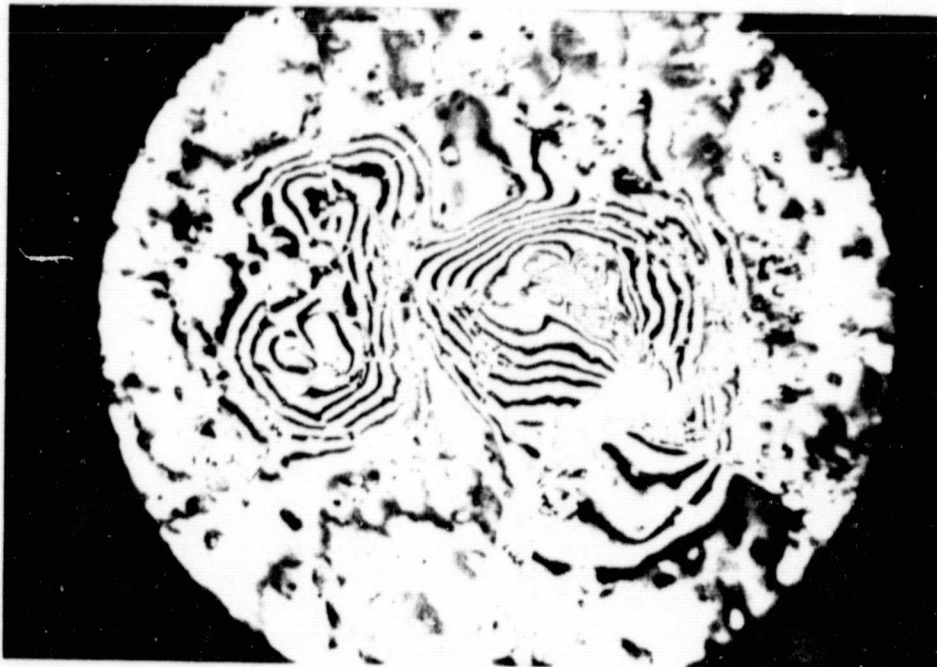
Figure 1: Defect A721-1-A (a) before and (b) after oxide removal. Magnifications are (a) 140 x and (b) 340 x.

At least three-quarters of the permanent defects occurred on six adjacent tracks along one side of the twenty track map, suggesting a repeating defect with a "wandering" transverse location similar to the base film asperity identified on 3M 5198, which was not included on any of the Table 2 samples. Practically every five foot sample on the affected non-edge tracks had dropouts on two adjacent tracks, suggesting an effective width of 11 to 15 mils. Generally bi-lobe signal envelopes suggest projecting oxide material, allowing average dropout lengths shorter than the indicated width and accounting for the atypically short average dropout length on Table 1.

Several copies of the repeating defect isolated from the Ampex 721 sample exhibited a minimum distance of 46 inches between copies. The interference micrographs of Figures 1a and 1b were taken before and after oxide removal respectively at one copy of the defect with the interference planes oriented parallel to the tape surface. A base film asperity is clearly indicated, and a thin oxide coating over most or all of the asperity is suggested by the absence of longitudinal scratch marks on the micrographs and the complex shape before removal of the oxide. The micrographs suggest a projection height equivalent to the 3M 5198 base film asperity but a narrower width at that height, correlating well with the 2-6 mil difference in effective widths reported for the two base film asperities.

*~40 μm high
implies a ~140
opacity in base
film*

*Base film defect
repeats most
cause C.O.*

Visual scanning and interference microscopy verified the presence of a second repeating base film asperity on this 1 inch wide Ampex 721 reel. Visual scanning suggested four more repeating base film asperities which could not be verified by the "before and after oxide removal" technique due to the textured base film surface visible around the perimeter of Figure 1b, which can obscure moderately spaced interference bands on irregular shapes.

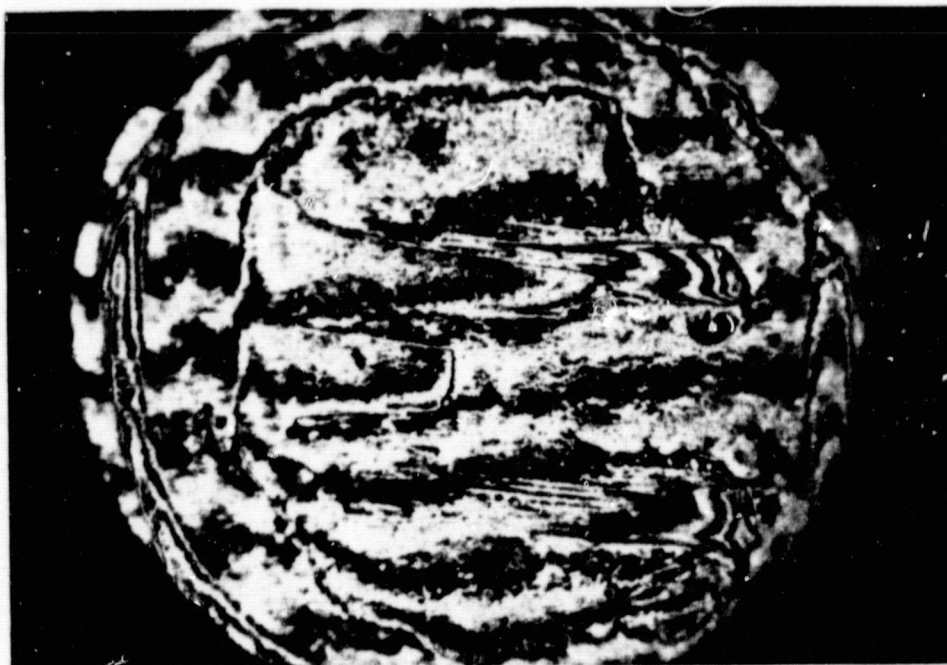
Figure 2: (a) optical and (b) interference micrographs of defect Ampex 721-2-A. Magnifications are (a) 140 x and (b) 340 x.

At least two additional permanent dropouts on the Ampex 721 sample were caused by copies of another repeating defect which only affected a single track. This distribution and width suggests a low profile projection (or a narrow depression) formed during a manufacturing step, which exhibits nominal transverse shifting compared with the wandering location

of the base film asperity. A 46 inch separation distance was also observed between copies of this defect, but distances between dropouts were irregular and much greater due to the borderline size of the defect and/or its position relative to track centers.

Figures 2a and 2b are micrographs showing the size and shape of a defect copy which was probably responsible for a dropout. The base film surface appeared normal after removal of the oxide, indicating a calendaring defect with streaks suggesting smearing of the defect material prior to curing of the oxide. The rim along the extreme left edge of Figure 2b projects 30 microinches above the tape surface. A shift of about 4 bands (40 microinches) is visible toward the right edge of the upper interior streak, but the width of that projection may cause less head to tape separation than the rim.

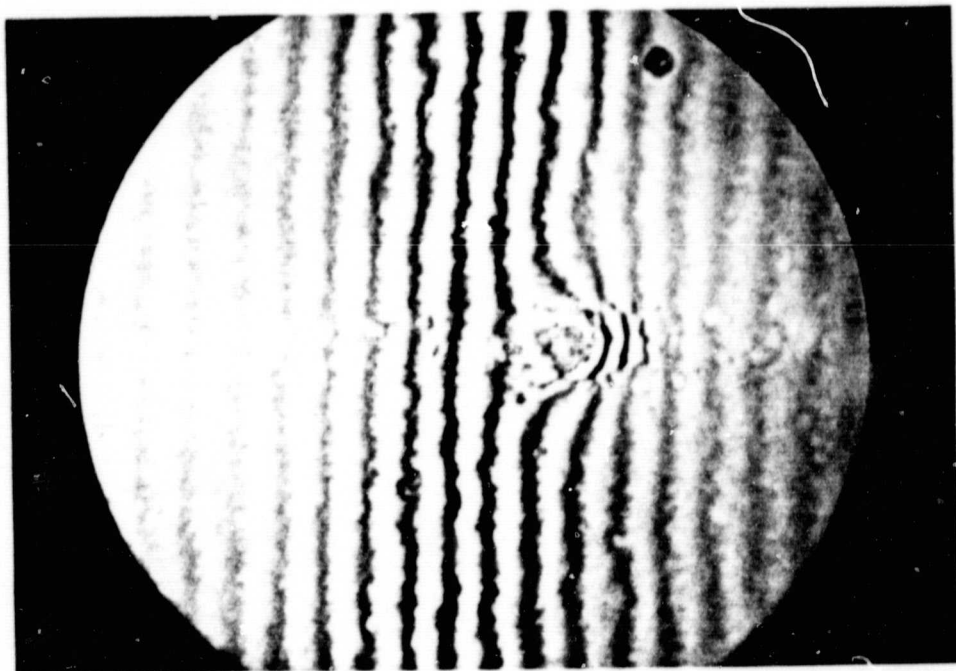
Figure 3: White light interference micrograph
of defect Ampex 721-3-A magnified 340x.

Figure 3 is a white light interference micrograph of one smeared defect located on the Ampex 721 sample. The 3.7 band shift on the smooth right portion of the defect indicates a 44 microinch projection. The rough surface on the left portion of the defect could obscure a greater projection. The optical appearance of this defect was similar to the common deposit defects of 3M 5198, and additional analytical characterization was not deemed necessary since this defect type is not a predominant cause of permanent dropouts on the Ampex 721 sample.
